# STS-107 Columbia Reconstruction Report

**NSTS-60501**

JUNE 30, 2003

Stephen J. Altemus,  
Columbia Reconstruction Director, NASA

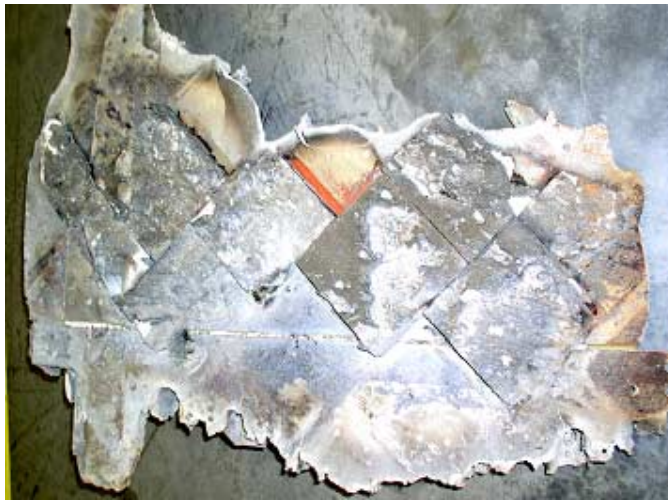
*Item 53827*

A few lower surface skin segments (52240, 1193) show heavy edge erosion. The aft inboard corner of the left hand wheel well where the Yo105 sidewall and the Xo1191 spar join, are two examples of this condition.

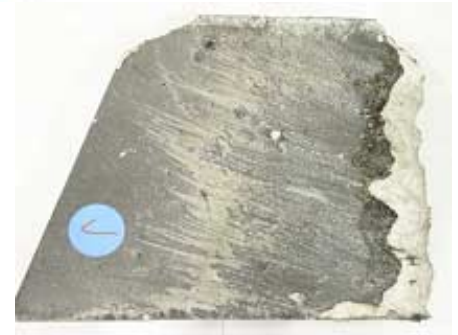
*Item 33590*

The majority of tiles identified in the MLGD region are concentrated around the perimeter of the outboard edge of the gear door. One tile, (33590), located on the outboard forward corner of the door has excessive heating. The erosion patterns

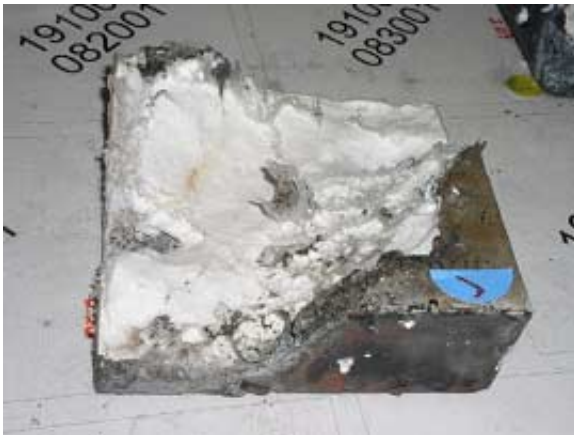
*Item 85472*

The tile (85472) is located inboard and aft from LESS access panel number 9 is the third most western tile found in the debris field. The design thickness was

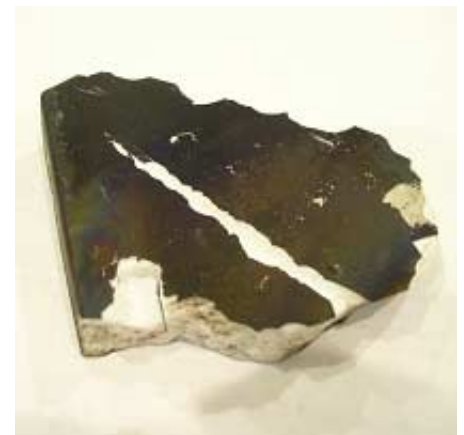
*Item 14768*

of upper wing LRSI tile, with black deposits covering the OML. The tile piece was not positively identified, however 3D evaluation and lab analysis indicated the tile could be placed in one of two locations. Both possible locations on the left and right wing are inboard of Leading Edge Structural Subsystem (LESS) upper wing access panels 8 and 9.

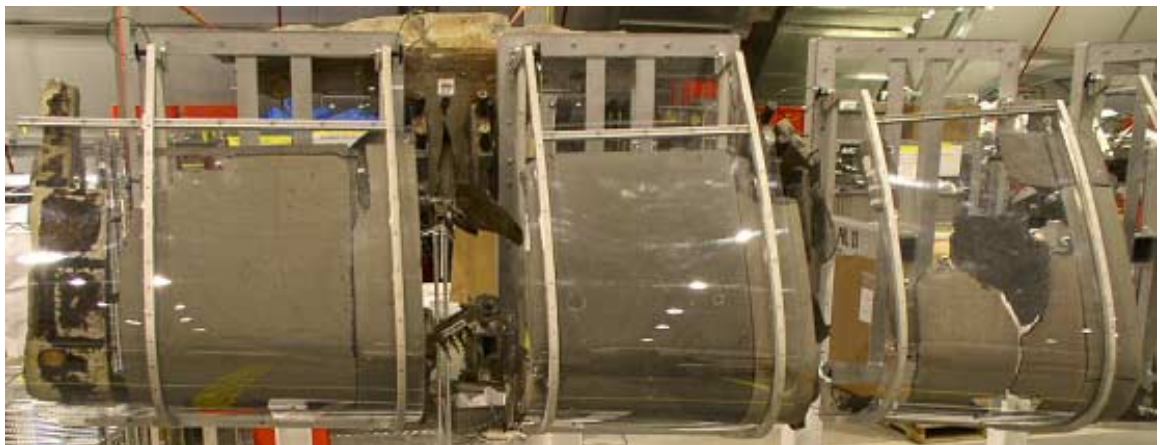
*Left Hand RCC Panels 1, 2, and 3*

All the RCC pieces in the glove region have fracture surfaces without signs of thermal erosion, though some of the fracture edges have substrate oxidation. The majority of the RCC lug clevis attach fittings were recovered. Uniform thin deposits on the interior of the panels contain Inconel, Cerachrome and aluminum at all deposition layers. The largest source of aluminum is the wing

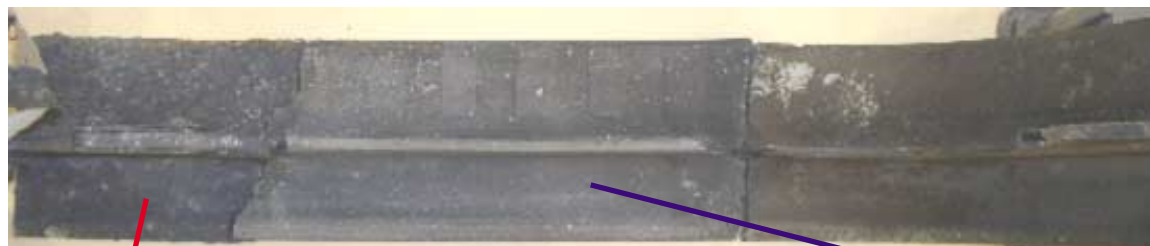
*Deposits*

based on deposit levels. Panel 2 and its associated gap seal have a heavy concentration of metallic deposits on one side of a fracture while the mating fracture surface is completely free of deposits. This condition is found on the gap seal (64823, 58575, 18474) where the middle

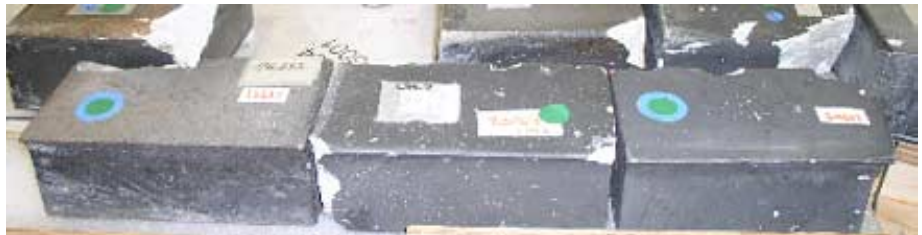
Panel 8 - Lower Access Panel Tile

There is no heat damage on any of the right hand panels. The only heat damage to the lower panels is to the tiles for left hand panel 9 (16692, 50338, 22571, 57754) on the surface adjacent to the RCC. Though the tiles exhibit severe heating, a portion of the aluminum access panel, as well as panel 8 and 10, survived with minimal heat effects.

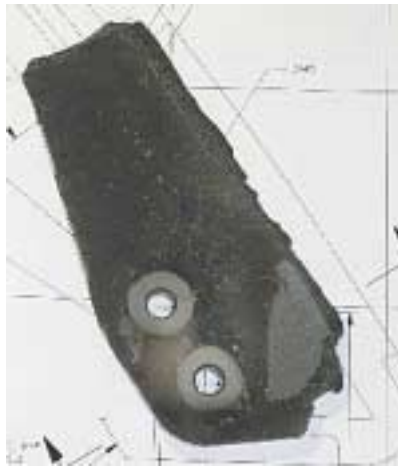
*Item 26014*

Panel	Lug Location	Item	Hardware Condition
7	Outboard	26014	Missing all hardware, except split bushings
8	Inboard	17957	Partial clevis, split bushing, aft bushing, no bolts
8	Outboard	61143	Missing all hardware, slag deposits in holes
9	Inboard	N/A	Lug was not recovered
9	Outboard	29741	Missing all hardware, including gap seal hardware
10	Inboard	34713	Missing all hardware, except one bolt with split bushing

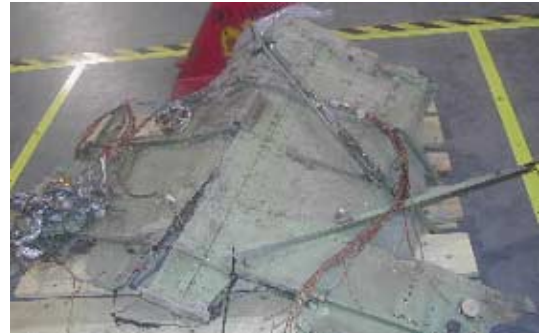
Item 2540/2218

for the doors. Only minimal evidence of thermal exposure is present. A large portion of the upper and lower drag brace assembly (2540 and 2218) was recovered. Both parts have broomstrawing and overload failures.

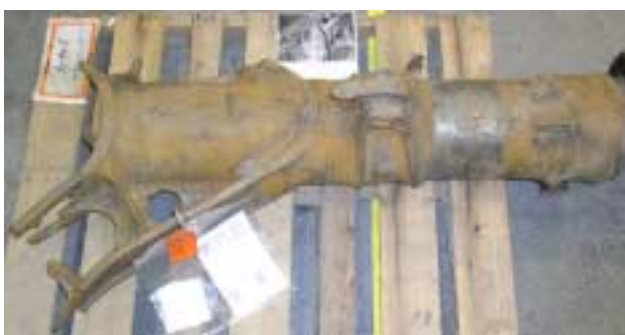
*Item 12697*

On the upper cylinder (12697), the gland nut threads are melted for two-thirds of the circumference and the uplock lug is melted away. The lower lug of the downlock link is attached and melted. One leg of the clevis is more than 80% melted away. The upper portion of the cylinder has extensive melting and distortion. The

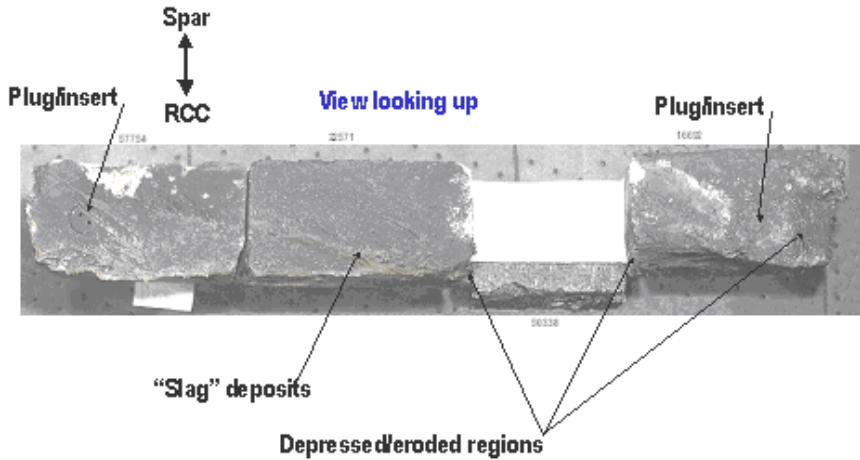
Figure 9.3. Top view of reconstruction lower left LESS Carrier Panel 9.

Evidence of overheating and slumping was observed on three LI-2200 Lower Left Carrier Panel 9 tiles adjacent to left hand RCC panel 9. The item numbers of tiles are: 16692 (V070-199716-048), 22571 (V070-199716-052) and 57754 (V070-199716-054). Figure 9.2 shows the simulated configuration of the carrier panel tiles. Depressed/slumped and eroded regions were observed in two of the three tiles (Items 16692, 22571). For

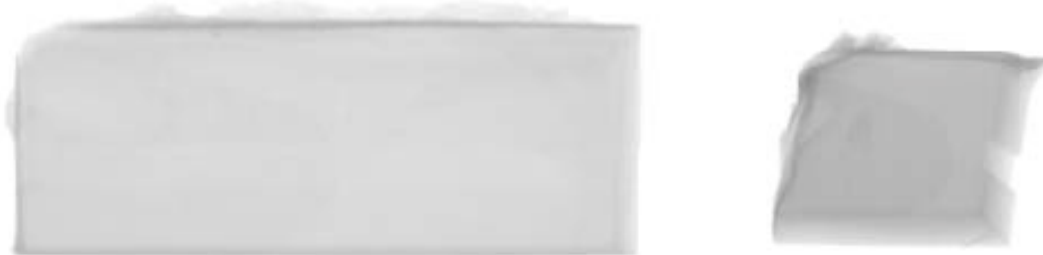
Figure 9.6. X-ray radiograph of tile Item 22571; front view (left) and side view (right)

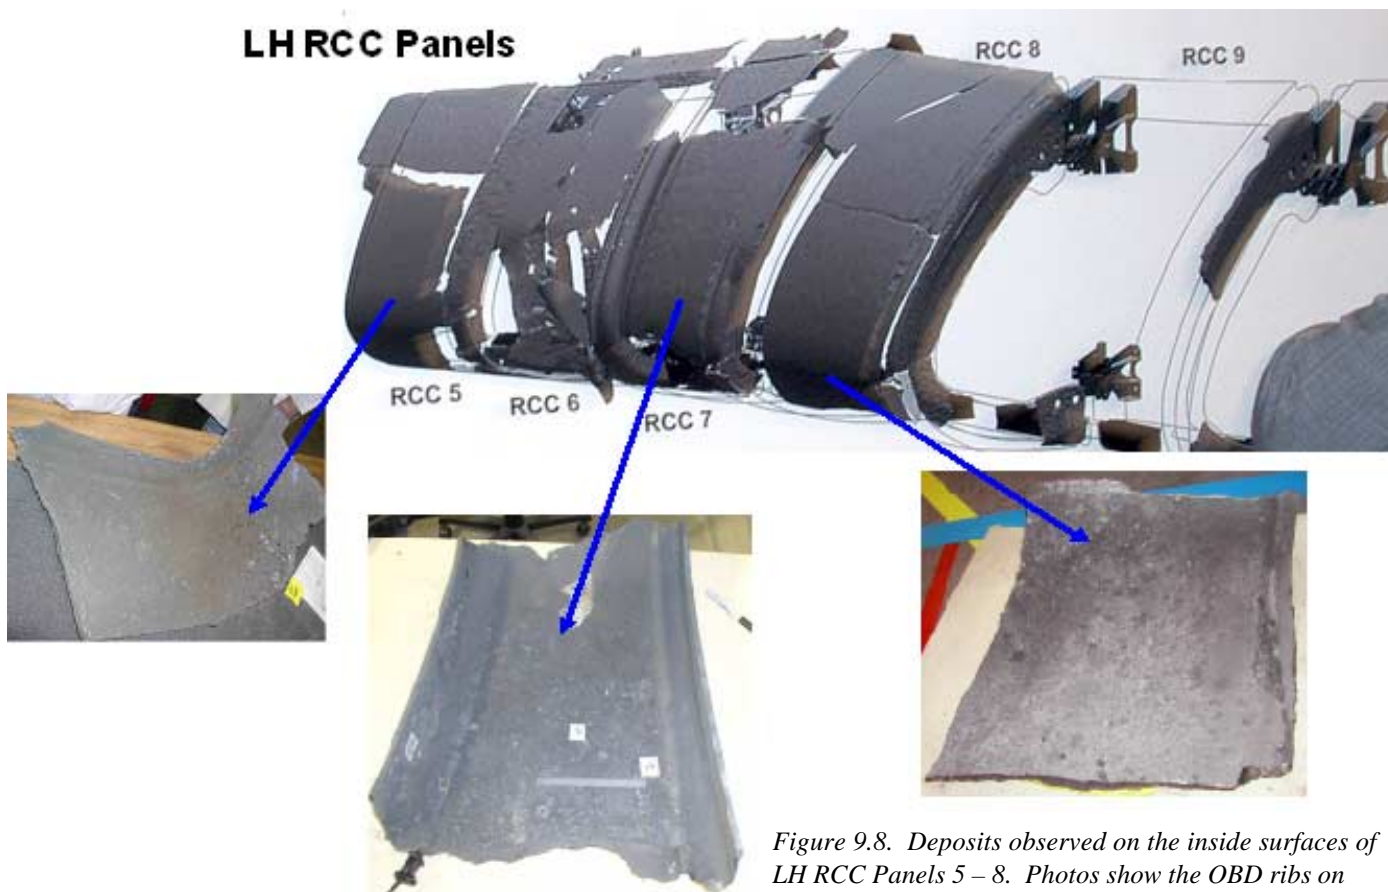
Figure 9.8. Deposits observed on the inside surfaces of LH RCC Panels 5 – 8. Photos show the OBD ribs on the Left and INBD ribs on the Right.

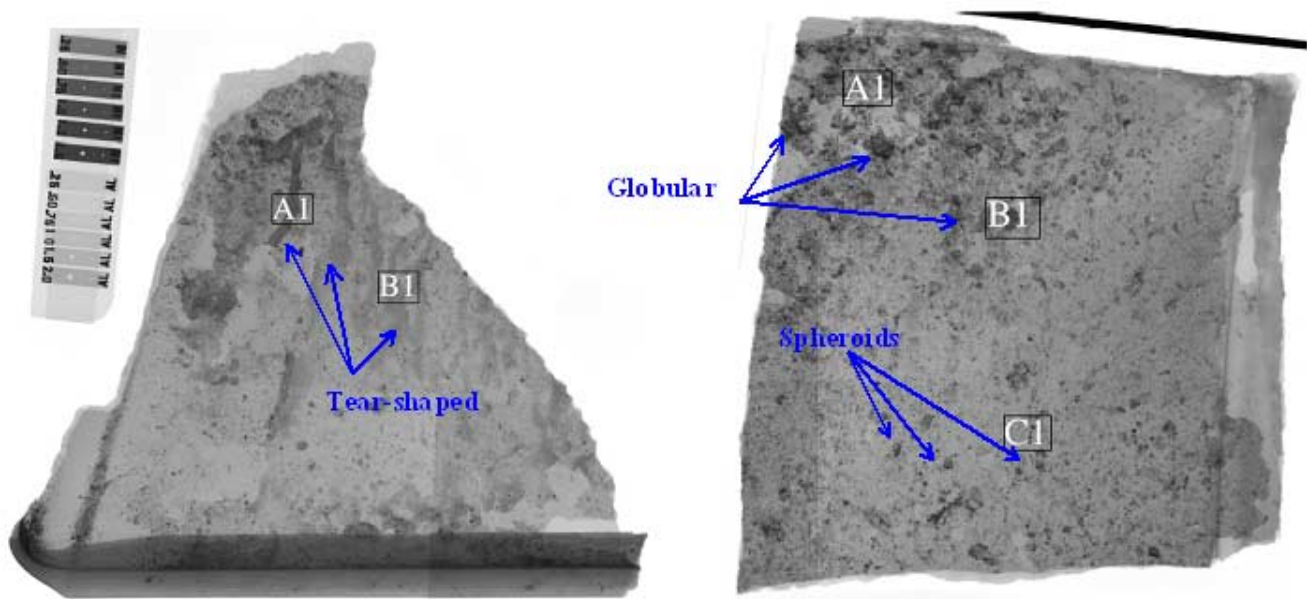
- The inverse radiographic response of heavier materials compared well with that of an IN718 standard
- Darker areas in the inverse radiographic images compared with the Inconel standard
- Aluminum and Cerachrome gave a similar radiographic response despite their diverse material characteristics
- Four types of deposit patterns were identified from LH RCC Panel 8 (Fig. 9.9)
  - Uniform thickness
  - Spheroids
  - Tear-shaped
  - Globular-shaped
- Other RCC panels imaged had Uniform thickness deposits

Figure 9.9. Types of deposition patterns observed on radiographic images of LH RCC Panel 8 pieces.

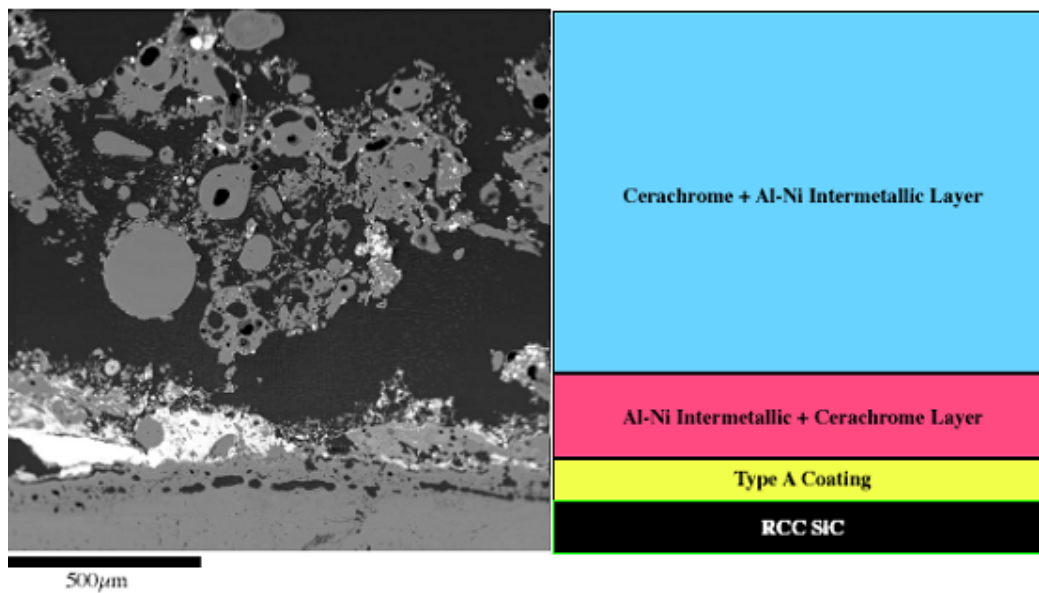
Figure 9.12. Cross-section of LH Panel 7 Upper (Item 31985)

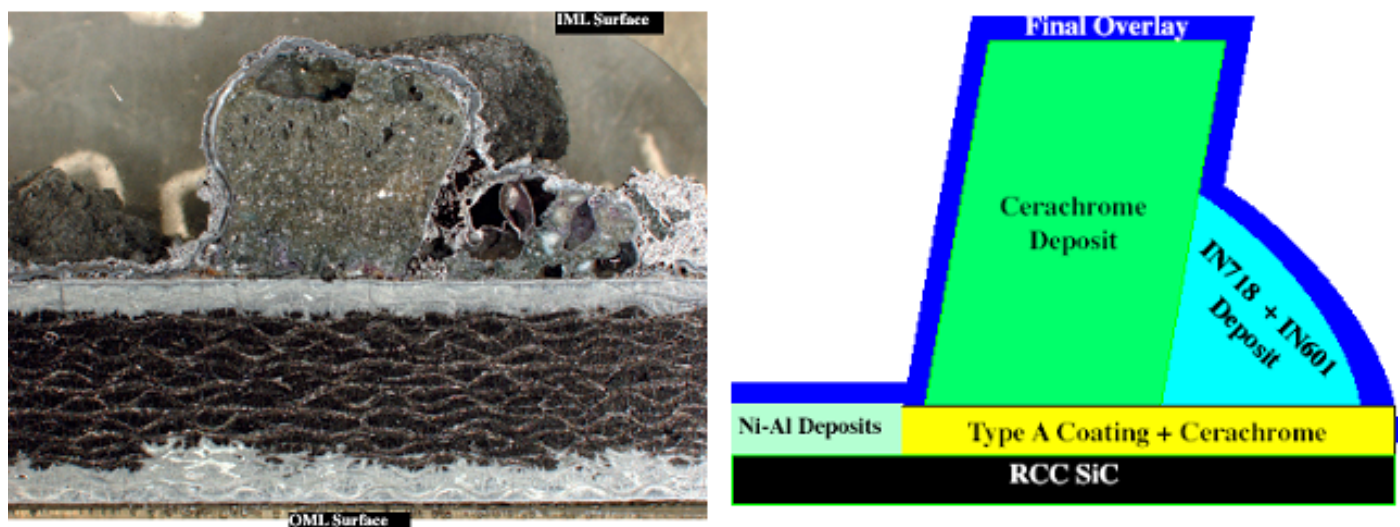
Figure 9.13. Cross-section of LH Panel 8 Upper (Item 43709)

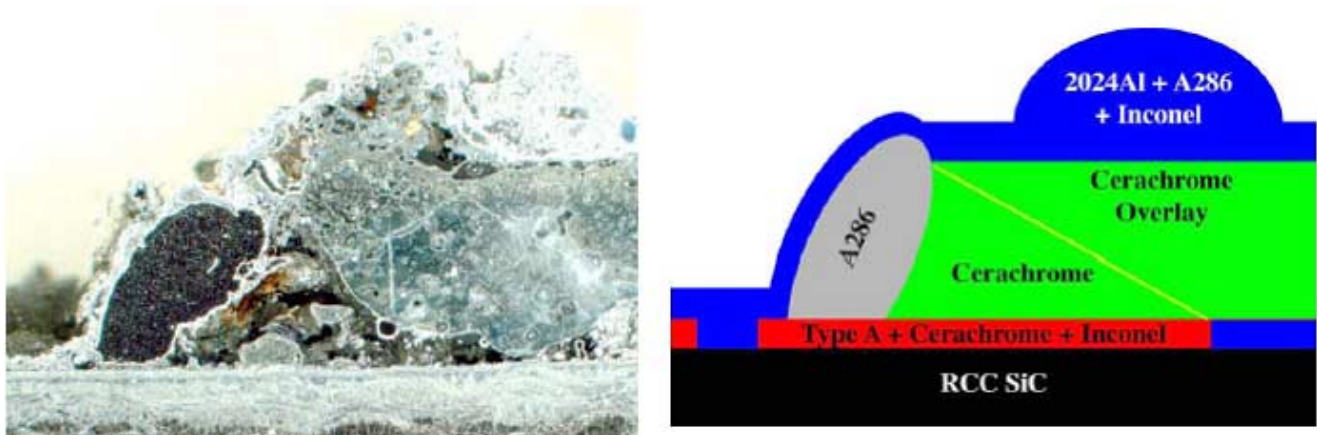
Figure 9.14. Cross section of LH Panel 8 Upper (Item 18477). The sample was removed near the inside of the panel's heel.

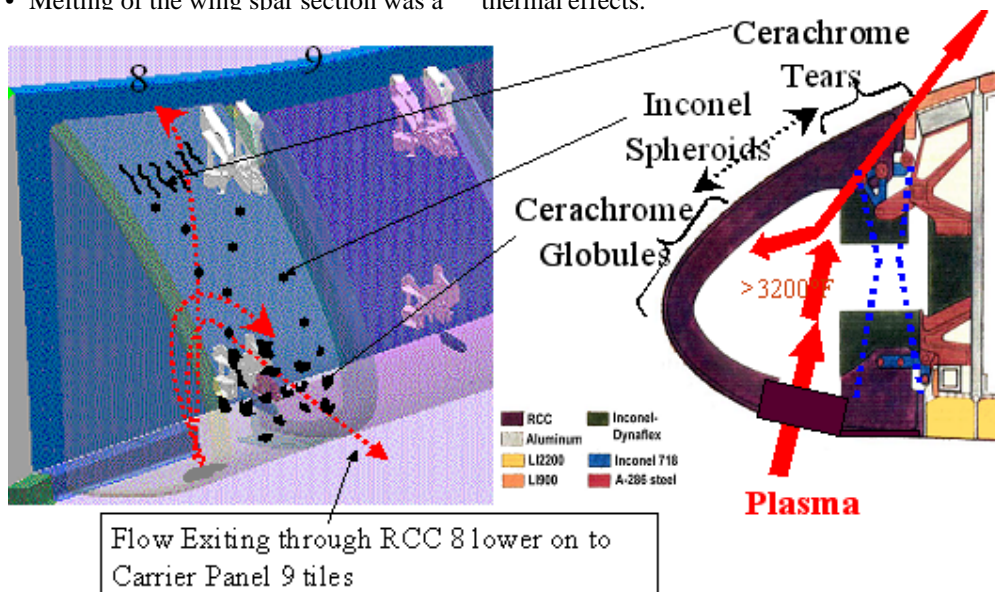
Figure 9.19. Schematic of deposition patterns analyzed near LH RCC Panels 8-9
